Are modern safety systems leading to deficiencies in post-accident control measures?

Martin Toland
STS Defence

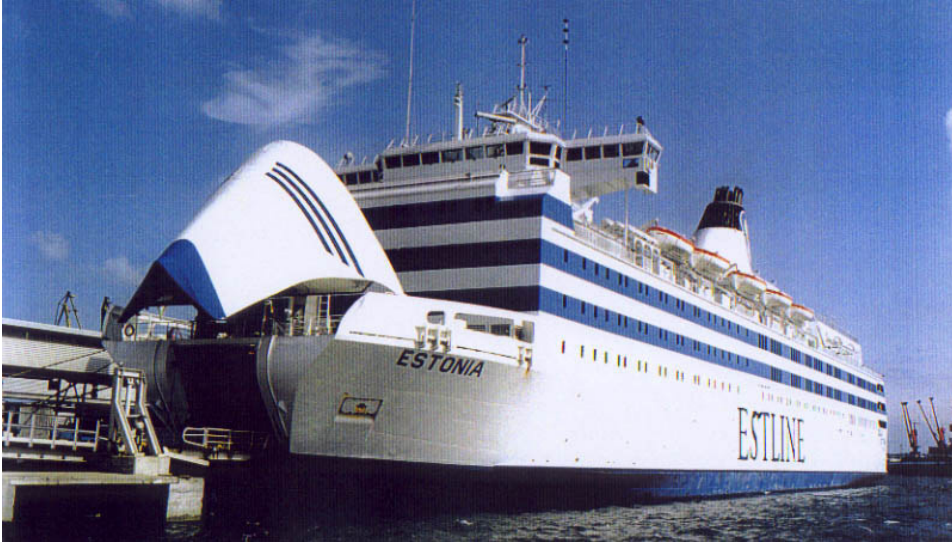
Fig 2. Estonia

Globally the marine industry spends significant time and money to ensure that ships are well designed, maintained and operated. Despite this, accidents occur which result in loss of life, vessel and goods. The example of the Estonia (Figure 2) shows adherence to requirements; the provision of indicator lights for the status of the bow doors. However this design feature was insufficient to prevent the sinking of the ship when damage was sustained to the bow.

The passenger ferry Estonia was sailing between Tallinn and Stockholm when she sank on 28 September 1994. It was established at the subsequent inquiry that the bow visor (shown raised in Figure 2) that was designed to protect the ship's ramp and access to the car decks had suffered a catastrophic failure. This led to it separating from the hull and pulling the ramp open allowing water to

access the car deck (HSVA, 2008). Although fitted, neither the door nor ramp sensors indicated as open on the bridge, because the nature of the failure was such that it did not move the sensor from the closed position. This system was a lesson identified after the Herald of Free Enterprise accident yet was not sufficient on this occasion to alert the bridge watch keepers to the failure that had occurred.

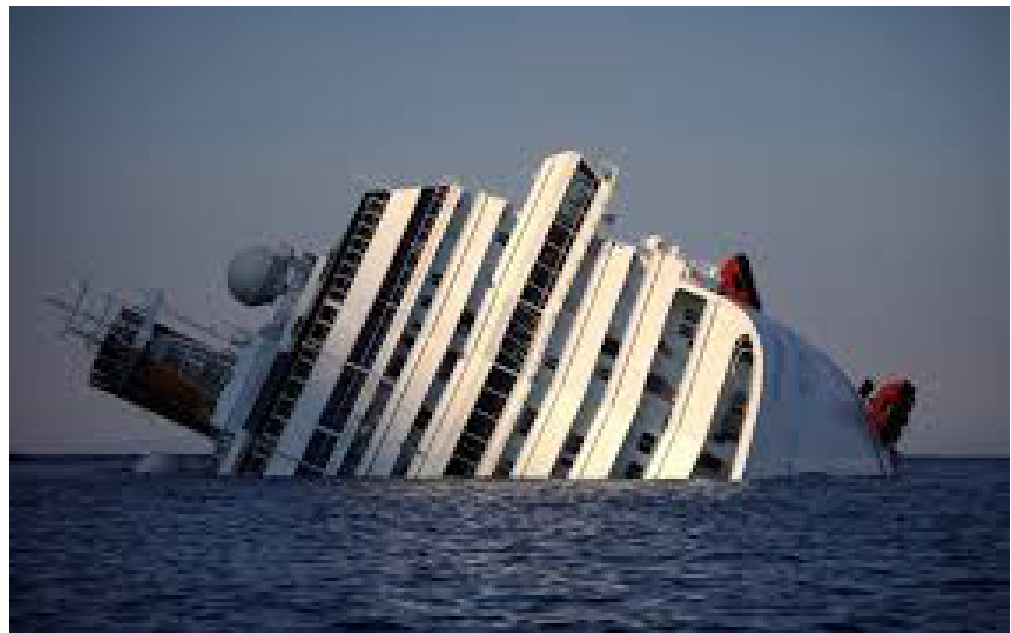
Fig 3. Costa Concordia

Without doubt the most prominent accident in recent memory is that of the cruise ship Costa Concordia (Figure 3). Unlike many accidents, where a ship will disappear beneath the waves, the wreck of the Costa Concordia has until very recently been sat on the foreshore of Isola del Giglio. Of note in figure 3 are the two life rafts hanging redundantly on the ship's port side unable to reach the water for evacuation and rescue.

As the example shows once a significant list had developed (regulations allow for up to 20°) the ability of crew to deploy and for passengers to use the life boats was severely limited and evacuation along corridors now became a desperate attempt to climb seeming vertical shafts. Costa

Concordia carried the mandatory number of life rafts and lifeboats (125% of the maximum number of personnel on-board), however some of the equipment on her starboard side was out of use by being under the overhang of the ship or submerged while that on the port side could not be lowered to the water because of the list. Sadly this demonstrates that adherence to regulation and class requirements may afford sufficient equipment, but does not provide any guarantee that it will be available post incident.

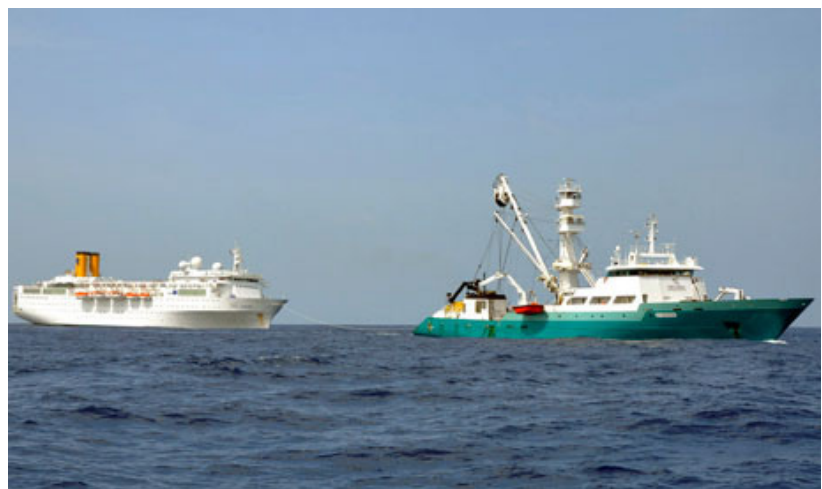
Fig 5. Costa Allegra under tow

An additional example is that of the Costa Allegra (Figure 5). On 27 February 2012 she suffered a fire in the generator room. In a testament to the fire suppression systems fitted on-board the fire was extinguished and there were no casualties however the ship was left without power (Carnival Corporation and Plc, 2012). The ship was taken in tow by a French fishing boat and taken to the Seychelles for repairs.
